Introduction

This information sheet will discuss aspects that need to be considered when preparing and sanding cork floors. As the procedures can differ between new and existing, these will be considered separately.

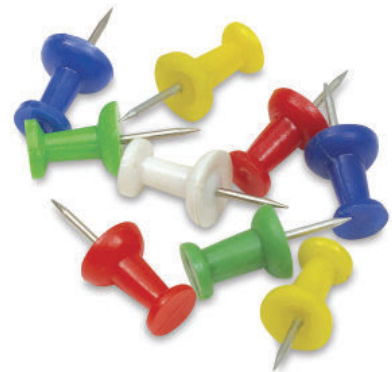
One method of determining the thickness of the tile is to use either a new blade of a Stanley knife or a drawing pin, as shown to the right. Push the blade or drawing pin into the floor and it will go through quite easily. Once it hits the subfloor it will stop. Mark the blade or drawing pin and measure the distance from the bottom of the blade or pin, to your mark. Many experienced floor sanders would not attempt to drum sand tiles that were not either

4.8mm or 6mm tiles at the time of installation. If the thickness of the tiles is 4.0mm or less this would likely indicate the floor has been drum sanded in the past or the tiles were a thinner tile when originally installed. Tiles thinner than 4.8mm were also often low density products. This test should be carried out in a number of locations throughout the floor to gauge whether there is an even depth of cork throughout. This test is however, not a guarantee, but if carried out in a number of places, it should provide a reasonable indication of whether the floor could be re-sanded or not. Another gauge to the possibility of the floor being drum sanded with past refurbishment would be sanding marks, including edger marks that may be apparent at the perimeter of the floor. Also, as part of a visual inspection, the condition of the floor should be assessed in terms of the adhesion of the tile to the subfloor as with poor adhesion it is also advisable not to re-sand the floor. Floor replacement may be the only option in such instances.

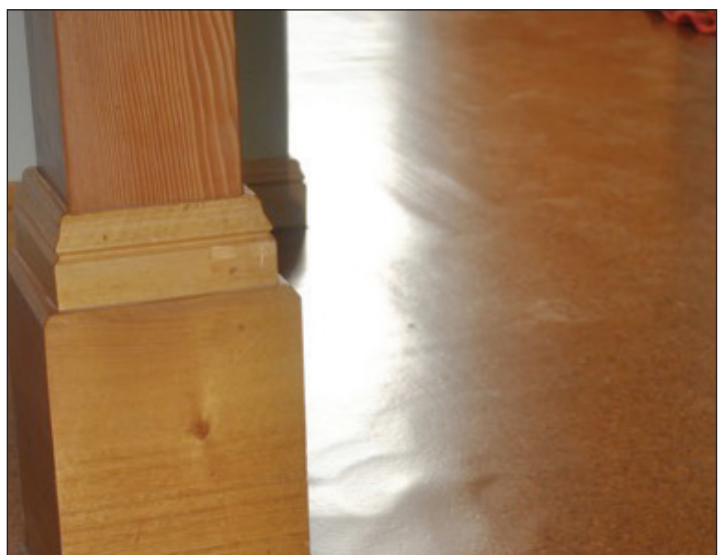
There have been instances where inexperienced operators have sanded cork floors too aggressively with belt or drum sanders and edgers. Sanding a cork floor, as if it is a timber floor, can result in problems occurring where the floor surface becomes uneven after the sanding. An example is shown in the adjacent photo. The standard AS 4786.2 Timber flooring Part 2: Sanding and finishing indicates that finish sanding should generally provide a smooth flat surface. Although this is recognised it also needs to be considered that the subfloor plays a significant role in how the finished floor appears, in regards
